**ASTM E 90 SOUND TRANSMISSION LOSS  
TEST REPORT**

**ZERO INTERNATIONAL**

**SERIES/MODEL: 4484**

Report No: 91778.01-113-11  
Revision 1: 08/06/09  
Test Date: 05/14/09  
Report Date: 05/22/09  
Expiration Date: 05/14/13

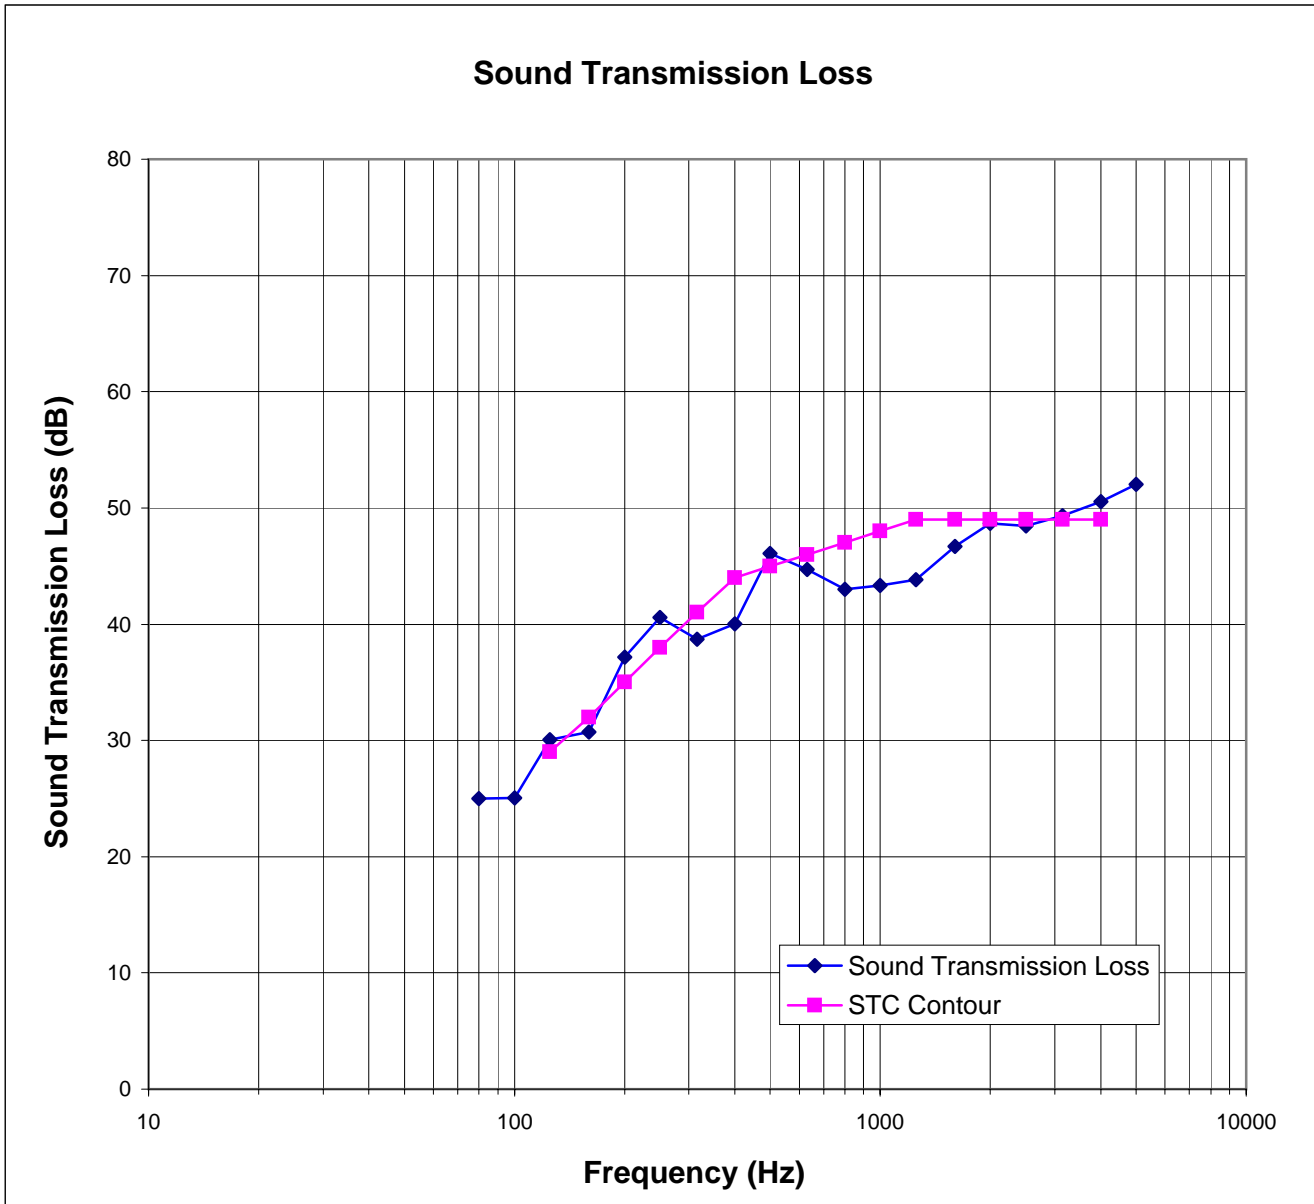
ATI No. 91778.01 Date 05/14/09  
Client Zero International  
Specimen Steel skin door with proprietary core with half lite 1-1/2" IG (1/4" laminated, 1" air space, 1/4" laminated), Glass temperature 75°F  
Specimen Area 20.73 Sq Ft  
Filler Area 119.27 Sq Ft  
Operator Kurt Golden

**STC Rating = 45**      *(Sound Transmission Class)*  
**Deficiencies = 25**      *(Number of deficiencies versus contour curve)*  
**OITC Rating = 37**      *(Outdoor/Indoor Transmission Class)*

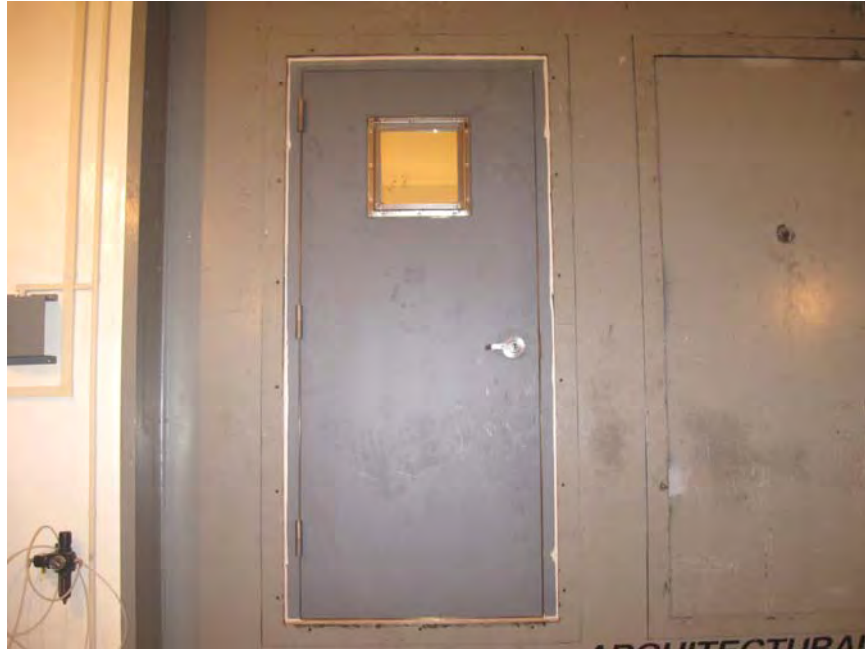
**Receive Room View of the Installed Specimen**

The 40" by 86" plug was removed from the filler wall assembly. The door system was placed on a foam isolation pad in the test opening. Duct seal was used to seal the perimeter of the test specimen to the test opening on both sides. The interior side of the door frame, when installed, was approximately 1/4" from being flush with the receiving room side of the filler wall. A stethoscope was used to check for any abnormal air leaks around the test specimen prior to testing. The door panel was opened and closed at least five times prior to testing.

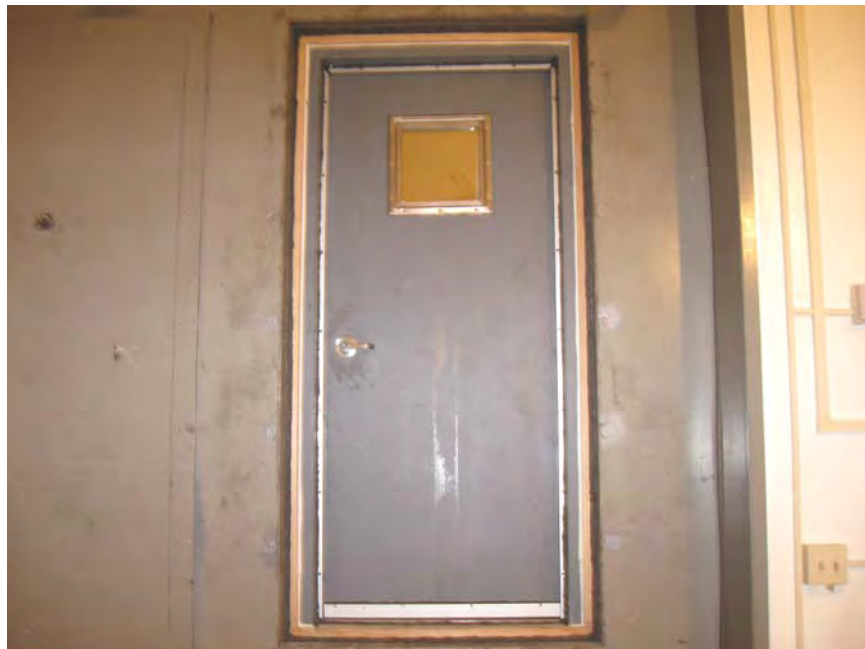
**Source Room View of Installed Specimen**
